CONTRACT NUMBER: FA8532-17-C-0008 (CDRL A002)

Evaluation of the Aircraft Ground Equipment (AGE) at Pacific Air Force (PACAF) Locations

Prepared by:
Battelle
505 King Avenue
Columbus, Ohio 43201

Date: 16 January 2018

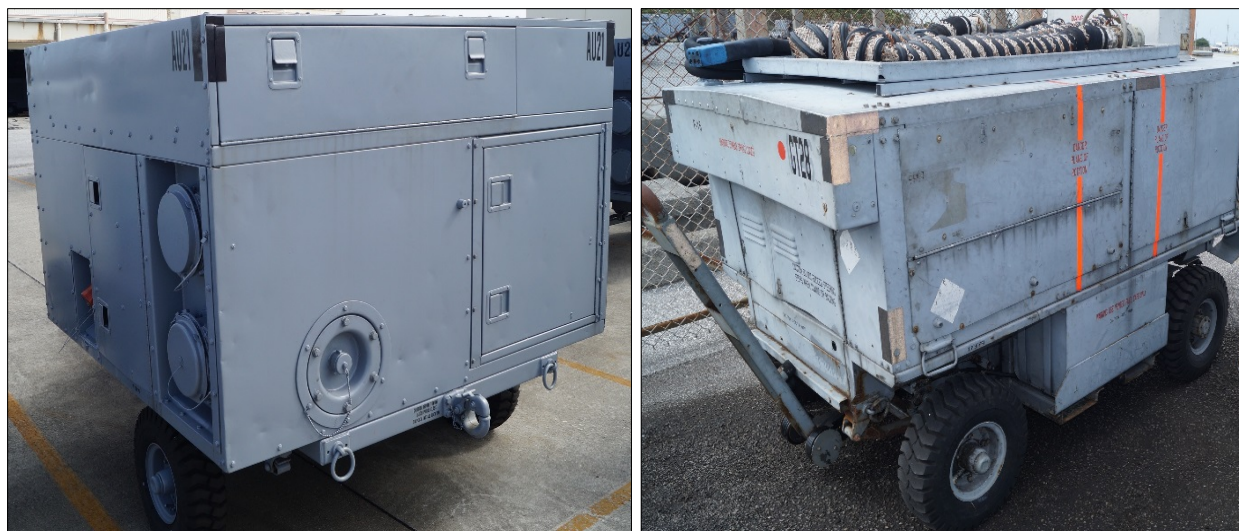
Figure 4. Photos of AGE in Kadena to show the loss of gloss over time

Significant loss of gloss can be seen between these two assets evaluated at Kadena. The AU-21 aircart was painted 1 month prior to this photo, while the GT28 generator was painted 60 months

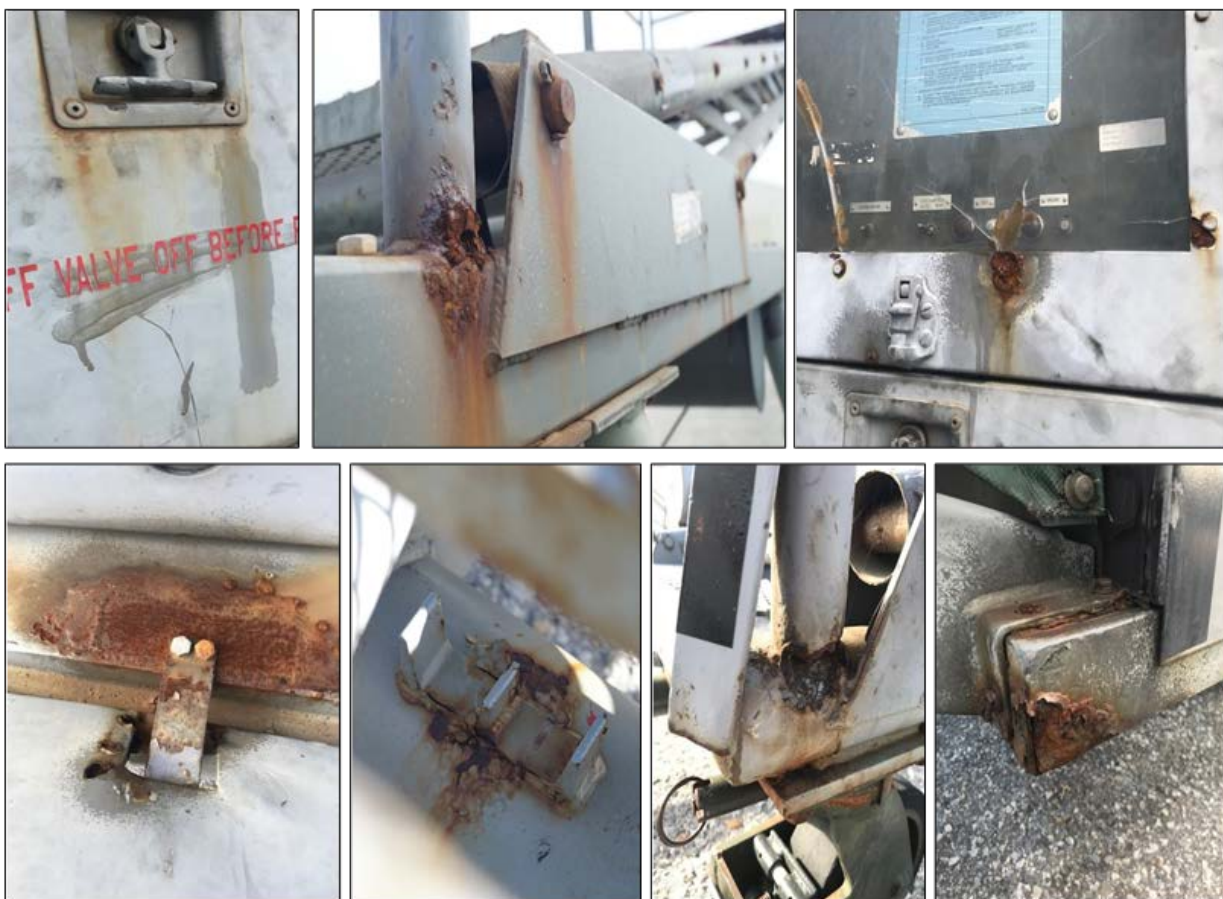
Figure 5. Corrosion observed on Inspected AGE at Kadena

Many of the corrosion products found on the AGE equipment at Kadena AB were in areas of bolts, leaf springs, under carriage, welds, and crevices between dissimilar metals. These are areas where moisture can collect and in the case of dissimilar metals an electrochemical process can occur in which one metal corrodes preferentially when it is in electrical contact with another, in the presence of an electrolyte. In the areas of welds, the problem arises from the fact that weld metal compositions (which are normally optimized for mechanical properties) tend to be slightly anodic to the parent steel. Therefore, the weld metal corrodes at a higher rate than the parent.

Photos of corrosion products found on AGE at Kadena AB. These are most likely the result of galvanic, crevice or preferential weld corrosion

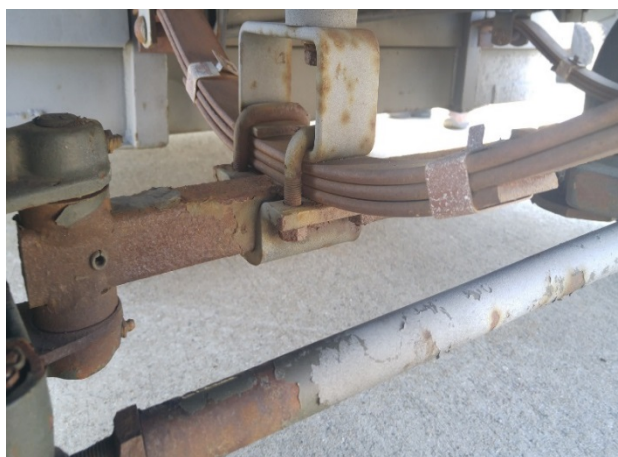
Figure 8. AGE Inspection Findings at Kunsan AB

Example of probable crevice corrosion or corrosion due to compromised coating seen on the undercarriage of AGE at Kunsan AB

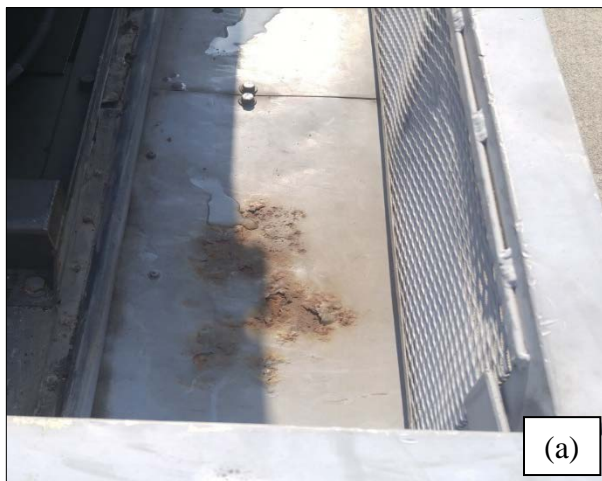
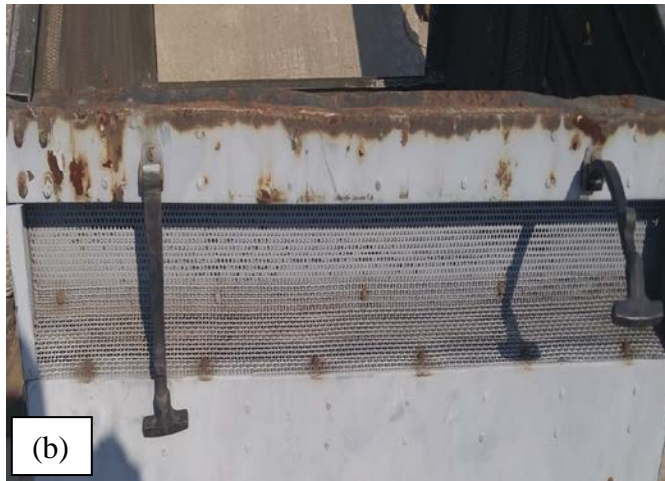
Figure 9. Additional AGE Inspections at Kunsan

(a) Example of Possible example of MIC from hydraulic oil. (b) Edge effects seen on the fairing of a Dash 95 TC 21 at Kunsan AB. Corrosion peeking through paint at corners is likely a result of edge effects and the coating naturally being thinner there, so it is the first spot to form pores and thus lead to corrosion

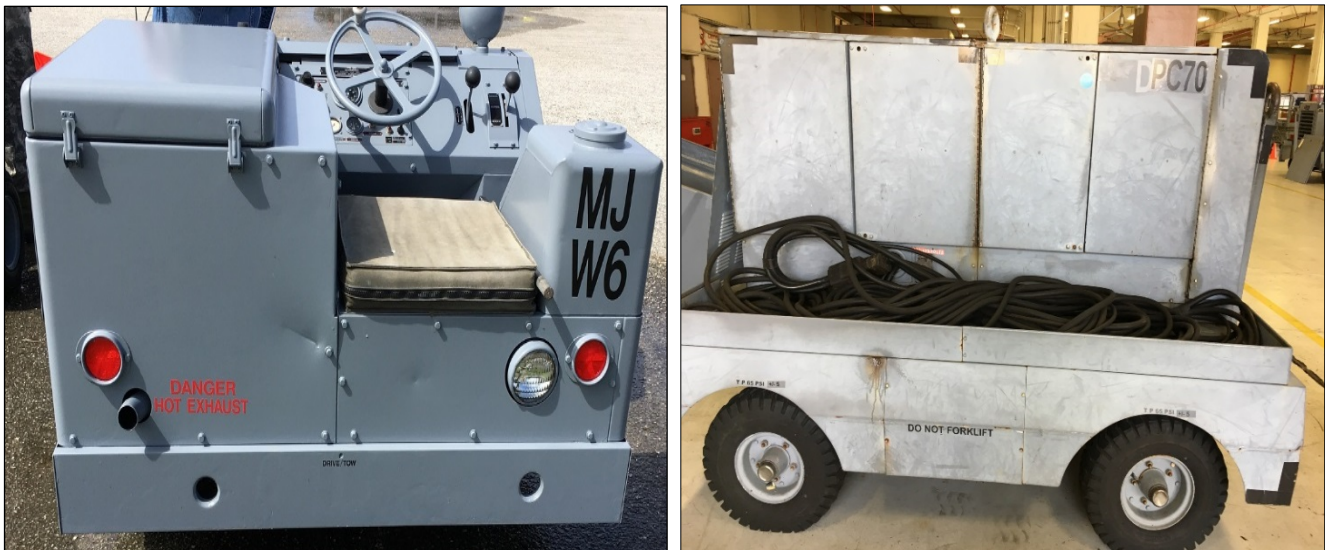
Figure 12. UV degradation of coatings at Andersen AFB resulting in loss of gloss

Figure 12 shows the striking difference in color and gloss from UV degradation on the bomb lift painted a month ago and the Dash 86 generators painted five year ago and Figure 13 shows corrosion damage on the inspected AGE at Andersen AFB.

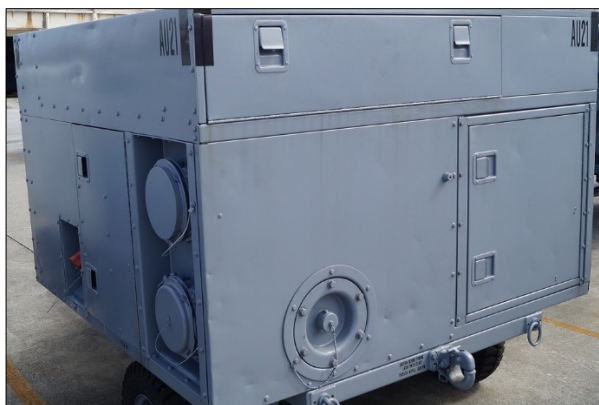
AU21 Kadena 1 month Gloss = 30.13

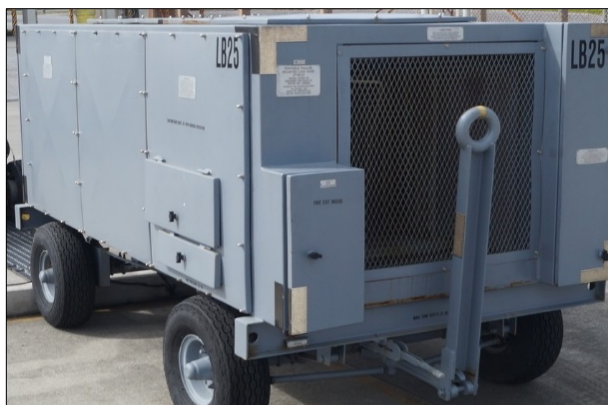
LB25 Kadena 3 months Gloss = 9.47

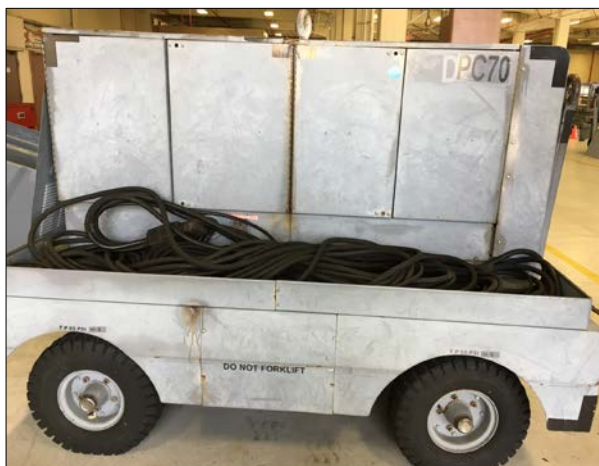
PC70 Andersen 60 months Gloss = 4.47

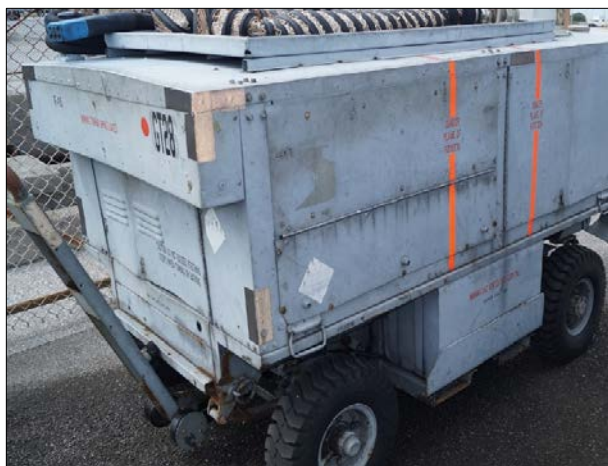
GT28 Kadena 60 months Gloss = 2.37

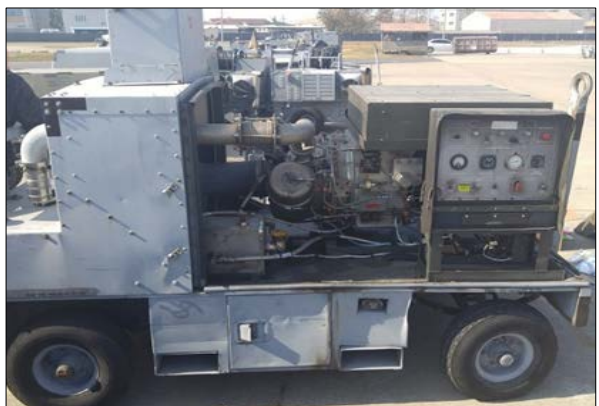
TC21 Kunsan 192 months Gloss = 1.53
